Rounded Out Coupler Damage

Overheated Fan Clutch (Melted Coupler)

Fan Clutch Piston Rod Damage

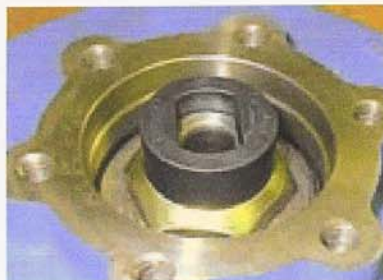
Figure 1 Pulley hub with coupler in place on shaft

The coupler is located between the rear of the fan clutch and the pulley hub center shaft. It is made of semi-hard black plastic, 1³/₈" diameter x 5/8" thick, with a flat sided

hole through the center. (Figure 1)

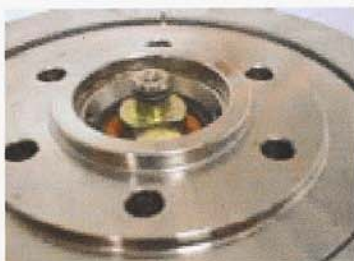
There is no load on the coupler during clutch operation. The coupler simply keeps the clutch piston rod (center shaft) from turning. It couples the piston rod to the shaft of the pulley hub by engaging both the flats of piston rod and the pulley hub shaft. The O-ring on the rear of the piston rod is the air seal between the clutch and pulley hub. (Figure 2)

Figure 2 Clutch with rear O-ring on piston rod

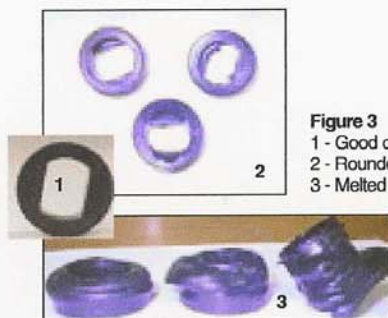
Rounded out damage to the coupler and rear O-ring failure

can occur when the clutch piston rod is forced to rotate. (Figure 3-2) This can be caused by a clutch bearing failure or improper clutch servicing. The clutch cylinder cap must be held

Figure 3
1 - Good coupler
2 - Rounded out coupler
3 - Melted couplers

stationary by hand when removing the front retainer nut. If the coupler is rounded out, the clutch ball bearings need to be inspected carefully. The clutch should be replaced if bearings are damaged or worn.

Always replace the coupler and rear O-ring when servicing the clutch or hub.

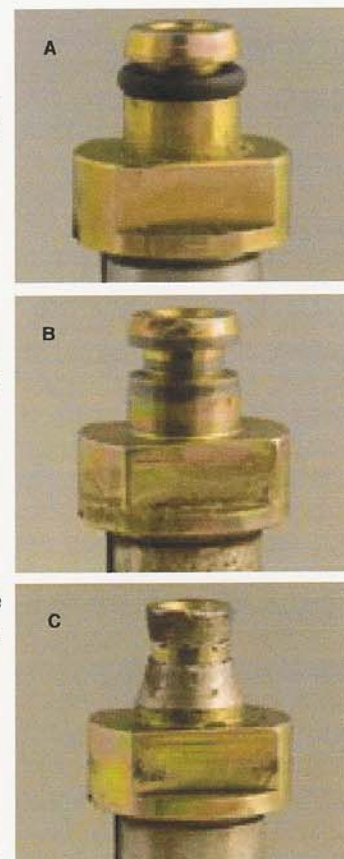
Damage to the rear of the piston rod (center shaft) and rear O-ring is usually caused by worn or damaged pulley hub bearings. This may first be noticed as an air leak at the rear of the clutch.

The rear portion of the piston rod enters into the front of the pulley hub shaft. Bearing wear or damage in the pulley hub may cause the pulley to not run true on the shaft. Bearing wear can cause damage to the rear O-ring and eventually the piston rod. (Figure 6) There should be no play in the pulley hub bearings. Check for scuffed plating on the piston rod around the O-ring area. Check for worn metal at the rear of the piston rod. If the metal is not damaged, the clutch can be reused.

Figure 6 O-ring area of new piston rod (Figure A), minor damage at rear of piston rod showing scuffed plating serviceable with repair kit (Figure B), and severe damage to rear of piston rod showing worn-away metal, not serviceable. (Figure C)

Always determine and correct the cause of failure. Inspect and make any pulley hub repairs or replace the pulley hub as required if worn or damaged. Pulley hub bearing kits are available for service.
