FAIL SAFE™ On/Off K26RA Rear Air Fan Clutch Series 1090-09500

INSTALLATION | SERVICE | TROUBLESHOOTING

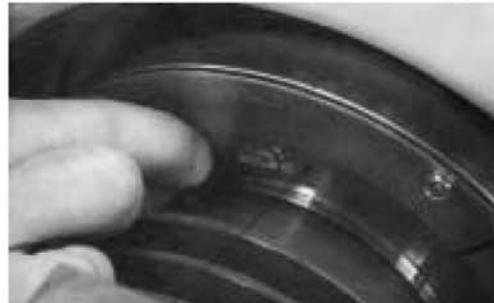
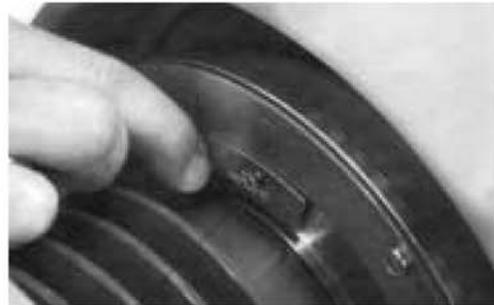
1. Start with the fan clutch engaged. (No air to the clutch.) If necessary, disconnect the air line from the fan clutch.
- The clutch in the top image has a brand new lining. Notice how the tool sits down in the pocket, below the surface of the lining retention plate.
 - The clutch in the bottom image has a lining that is worn to the point where it should be replaced. Note how the tool protrudes above surface of the lining plate.
2. Order a new lining when the tool is exactly flush with the plate, and change it at the next scheduled service. Instructions for changing the lining are included in the lining kit, part# 1033-09340-01.

This tool is a "go/no-go" gauge that will indicate whether the lining is close to wearing out and needs replacing.
